## Review of recent incidents involving flammable mists

Mists and sprays of high-flashpoint fluids can cause flash fires or explosions. However, guidance by industry on hazardous area classification to address these risks is limited. This paper presents a summary of recent work in this area and analyses three incident databases to establish common factors and trends in flammable mist incidents. The three incident databases are the UK Hydrocarbon Release Database (HCRD), the French ARIA and German ZEMA databases. The HCRD data shows that over a 30 month period starting in 2016 around 10% of reported releases on offshore oil and gas installations on the UK Continental Shelf involved mists or sprays. There were 25 incidents of which two ignited. The ARIA and ZEMA databases show that mist and spray releases of high-flashpoint fluids such as lube oil, hydraulic oil and diesel have led to significant incidents in a wide range of different industries.

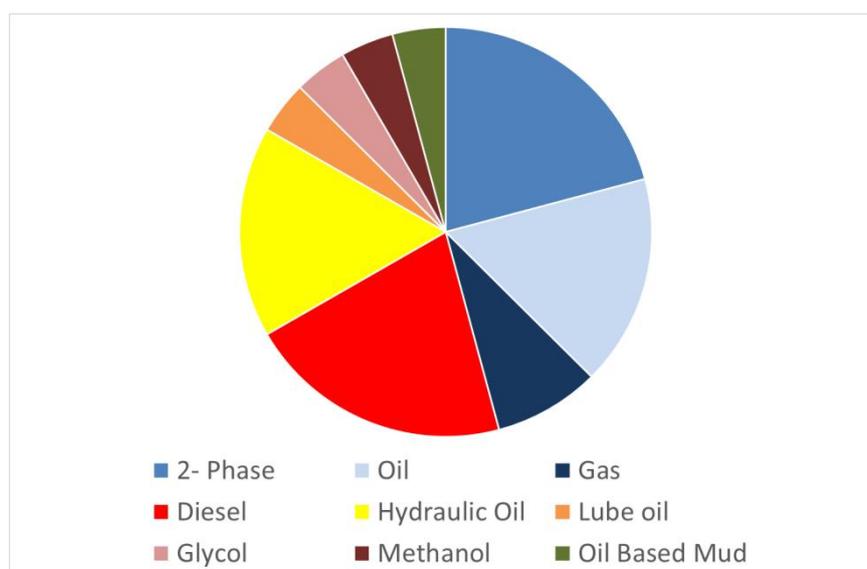
Figure 1: Proportions of the various fluids released in the HCRD spray / mist incidents

Figure 1 below shows the types of fluids released in the reported spray / mist incidents. Less than half of the reported spray / mist releases are process fluids. In total, 20% of the reported releases were from diesel sources. Hydraulic oil and lubricating oil comprised another 20% of the releases. These findings are broadly in keeping with earlier analysis of the HCRD (Burrell, 2014) which showed that of 48 flash fires in the period from 2000 to 2005, 34 were of these substances (11 diesel, 3 hydraulic oil, 20 lubricating oil).

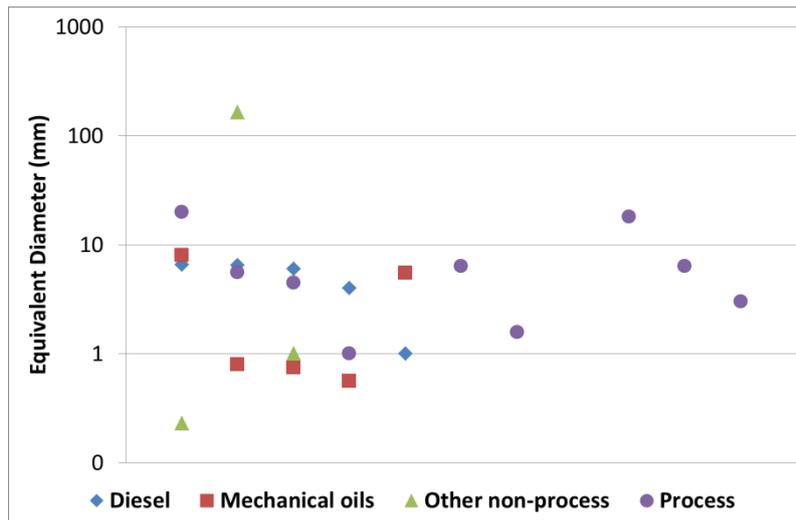
Figure 3: Equivalent diameter of the orifices for the HCRD spray / mist release incidents

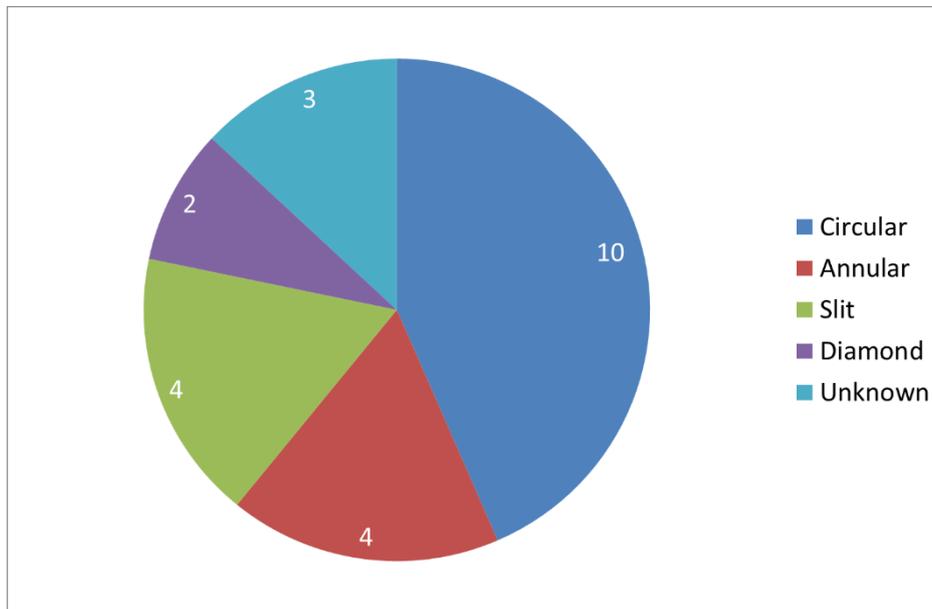
Figure 4: Hole geometry for the spray / mist releases

An attempt has been made to identify the shape of the holes based on the descriptions given in the HCRD. There are four categories of hole shape: fully circular, annular, slit shaped and diamond shaped. Figure 4 below shows the proportion of the holes in each category. For the purposes of shape classification, releases described as “pinhole releases” (4 in total) have been classed as circular. Nearly half of the releases had a circular shape (10 out of 23 releases). Details of the hole shape were not provided for three of the releases.

A further issue raised by analysis of the HCRD incidents is that around half of the incidents involved a release from an orifice that was non-circular in shape. The previous JIP only considered releases from a plain circular 1 mm diameter orifice, with a length to diameter ratio of 2. Whilst work has been done on sprays from different-shaped orifices, this has primarily been driven by different types of applications, e.g. fire suppression and fuel injectors. It is unclear if this data can be applied equally within the context of process safety, where releases may be produced by leaking flanges or corrosion holes.

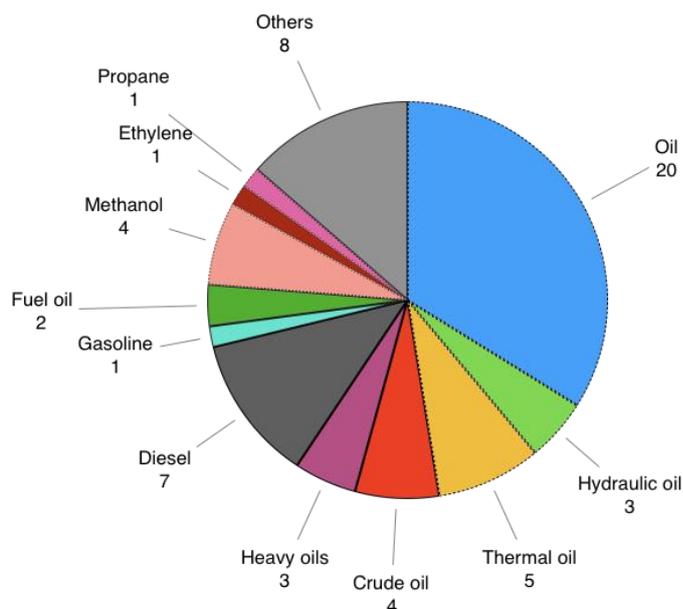
**Figure 5: Proportions of the various fluids released as a spray / mist from ZEMA and ARIA database**

Accidents from the ZEMA and ARIA databases mainly concerned oils (thermal, hydraulic or lube oils – 27 cases out of 40 for the ARIA database), liquid fuel hydrocarbons (crude oils, diesel, gasoline, fuel oil, kerosene – 8 out of 40 cases) or other minor compounds such as methanol, liquefied ethylene or propane. Figure 5 shows these incidents according to the material released
